Manhole Inspection Summary

Manhole # S33KK_044MH

Insp Date: 11/30/06 11:52 AM

Location Address: **1901 HOWARD ST**

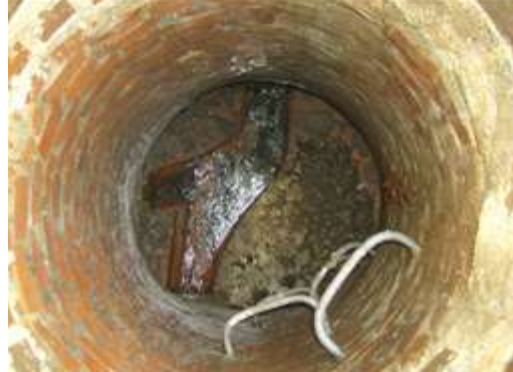
Top View

Frame leaks. Adjustment, Corbel and Barrel infiltration. Evidence of surcharge - Bench debris. Channel debris.

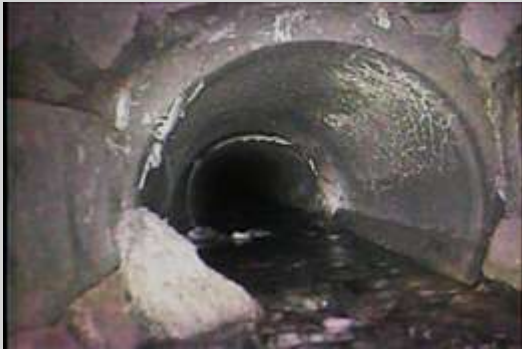
8 in. Circular Gravity Sewer Pipe Out @ 12 O'Clock

Deposits: ☐ None ☒ **Mud** ☐ Sludge ☒ **Debris** ☐ Grease

Silt Depth: **0.5** (in.) Deposits Extent: **Light**

Infiltration: **Evidence** Pipe Seal Cond: **Unknown**

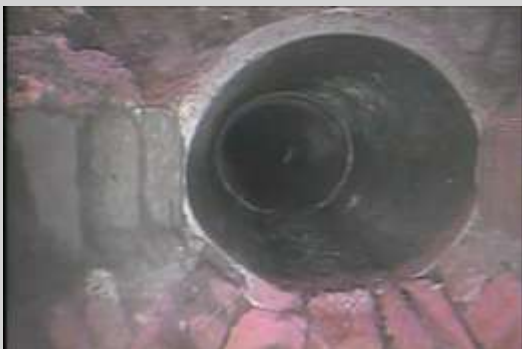
10 in. Circular Gravity Sewer Pipe In @ 7 O'Clock

Deposits: ☒ None ☐ **Mud** ☐ Sludge ☐ **Debris** ☐ Grease

Infiltration: **None** Pipe Seal Cond: **Unknown**

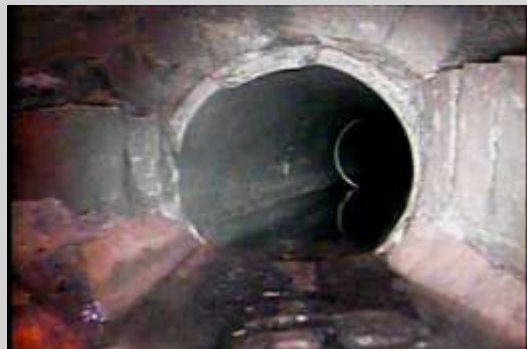
8 in. Circular Gravity Sewer

Deposits: ☐ None ☒ **Mud** ☐ Sludge ☒ **Debris** ☐ Grease

Deposits Extent: **Light**

Infiltration: **Evidence**

Pipe Seal Cond: **Broken**
